# Renovation of the Flora tram line intersection

## Data and facts

| Type | Railway construction |

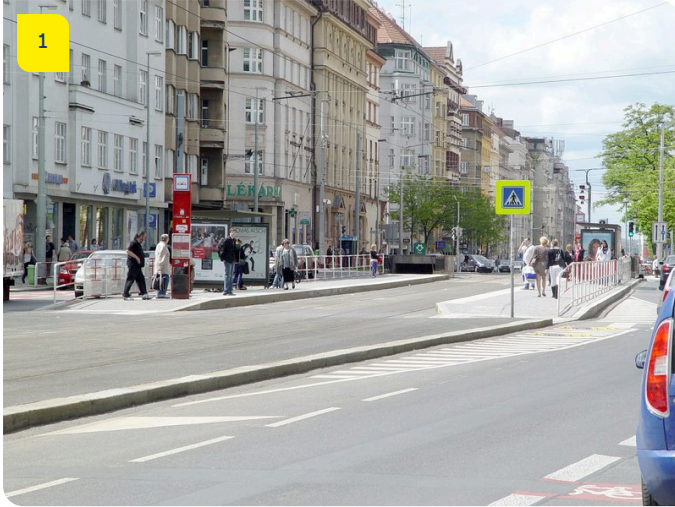
1

All-inclusive renovation.

This project included the complete renewal of the tram lines and tram stops.

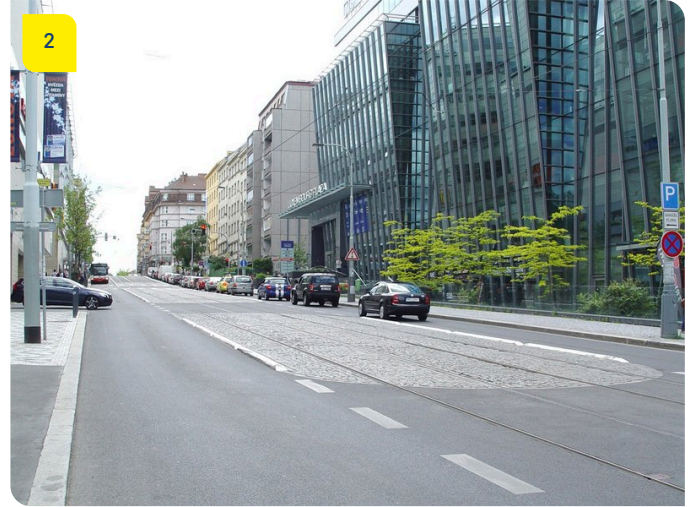
2

Critical point.

The Flora tramway intersection is an important traffic junction. Accordingly, the renovation works were of particularly high significance.

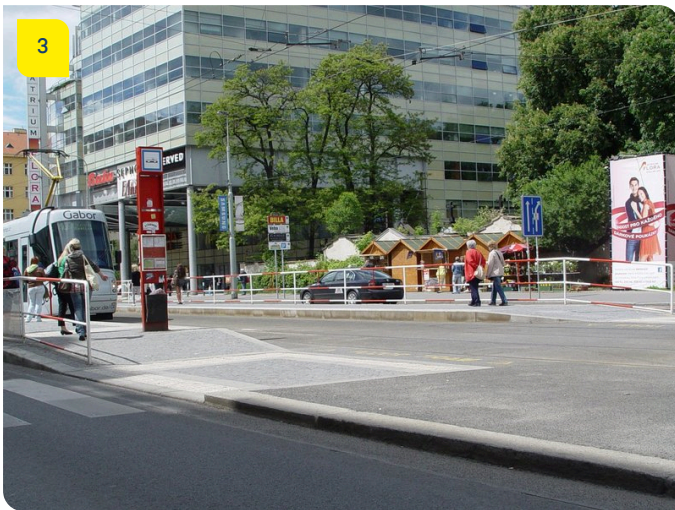
3

High-quality execution.

A mosaic pavement was constructed in the course of the tram stops' renovation.
